# COMBINED FIRE AND HEALTH & SAFETY RISK ASSESSMENT.

| Address of premises: | 49-71 Farriers Close,<br>Swindon,<br>SN1 2QX |
| Date of fire risk assessment: | 19 <sup>th</sup> September 2024/ Reviewed September 2025 |

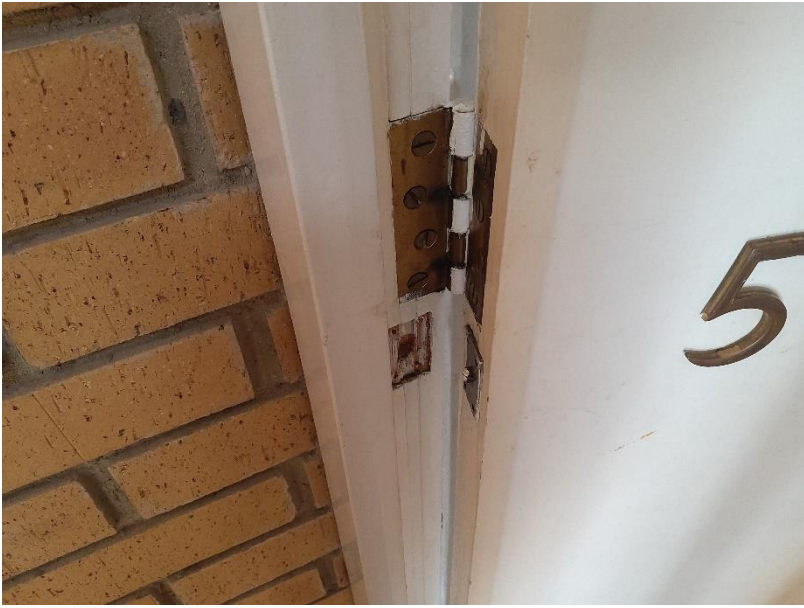
| 05 | <p>As per section 33.2 of Fire Safety in Purpose-Built Block of Flats a type 1 fire risk assessment requires us to conduct a fire door survey on a sample of flat front doors. The doors to flats 59 and 67 were surveyed during this sample which appeared to be a notional fire door however they had no fire rated hinges, smoke seals and self-closing devices.</p> <p>It is essential that each flat entrance door is a suitable fire door, providing a minimum of thirty minutes fire resistance, hung on three grade 13 hinges and having a functioning self-closing device fitted that positively closes the door on the latch, together with smoke and intumescent seals. It is recommended therefore that the RP instruct a suitably qualified and competent contractor to conduct a fire door inspection to all flat entrance doors and communal area doors providing advice on suitability. Any shortcomings identified by this inspection should be addressed as a priority by upgrading or replacing the door.</p> <p>Flat entrance doors, communal area doors, the seals and the self-closing devices should then be subjected to an annual inspection and maintenance schedule.</p> | 1 | B | <p>Action required</p> <p>DH inform owners to obtain compliance</p> <p>Last inspection carried out June 2025</p> |

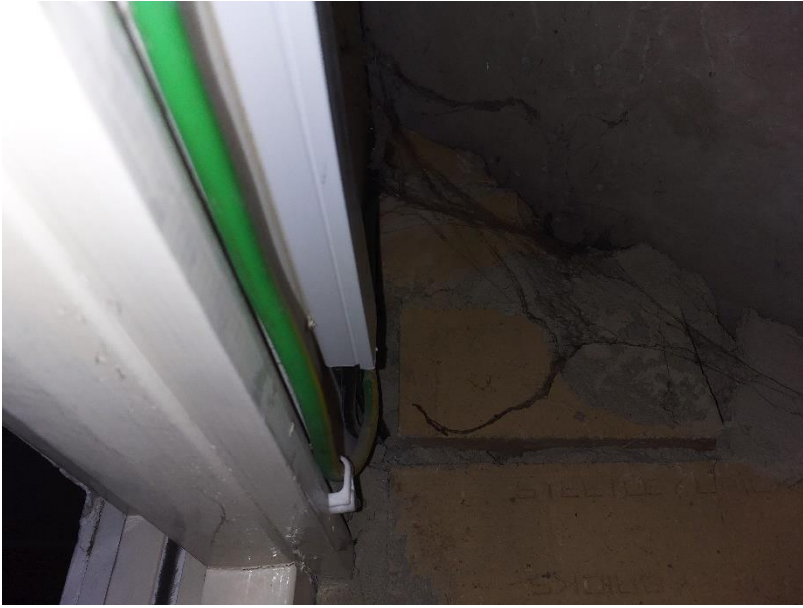
| <p>It was noted during this fire risk assessment that the compartmentation between the electrical intake cupboards and the communal areas were poor with fire stopping missing in areas or daylight shining through in breaches to the means of escape. The means of escape must be a protected route from any smoke or fire. It is therefore recommended that the RP instructs a suitably qualified and competent contractor to conduct a passive fire survey on all electrical intake cupboards, any deficiencies found should be actioned as a priority in order to protect the means of escape.</p> <p>It was noted during this fire risk assessment that there were large cracks in the fire stopping material on the first-floor communal area which could affect the integrity of the fire resistance. It is recommended that the RP instructs a suitably qualified and competent contractor to repair or replace the fire stopping in order to protect the means of escape from smoke and fire with a minimum of thirty minutes fire resistance.</p> | | |

| 07 | <p>It was noted during this fire risk assessment that the compartmentation between the electrical intake cupboards and the communal areas were poor with fire stopping missing in areas or daylight shining through in breaches to the means of escape. The means of escape must be a protected route from any smoke or fire. It is therefore recommended that the RP instructs a suitably qualified and competent contractor to conduct a passive fire survey on all electrical intake cupboards, any deficiencies found should be actioned as a priority in order to protect the means of escape.</p> | 1 | B |

Action required Contractor to make repairs

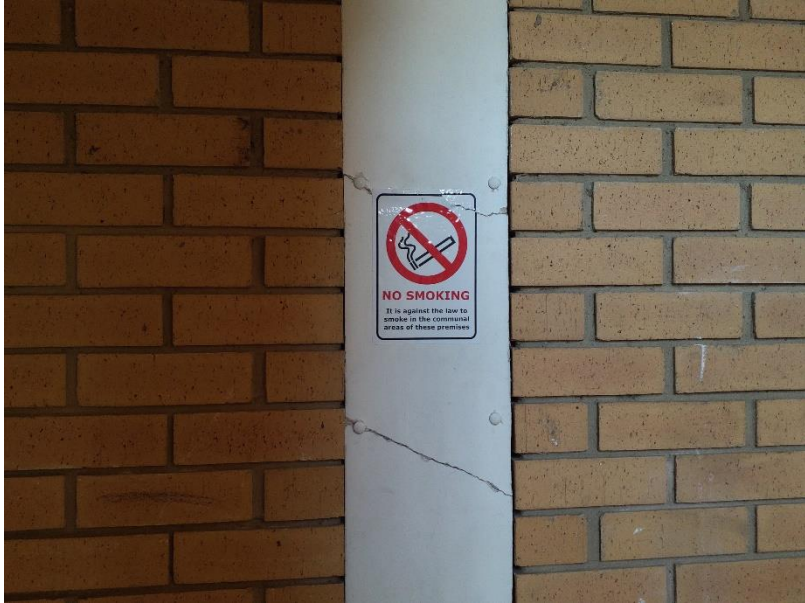
| 08 | <p>It was noted during this fire risk assessment that there were large cracks in the fire stopping material on the first-floor communal area which could affect the integrity of the fire resistance. It is recommended that the RP instructs a suitably qualified and competent contractor to repair or replace the fire stopping in order to protect the means of escape from smoke and fire with a minimum of thirty minutes fire resistance.</p> | 2 | B | <p>Ongoing action required</p> <p>RP to consider repairs. Risers contain water pipework and are located in main stairwell.</p> |

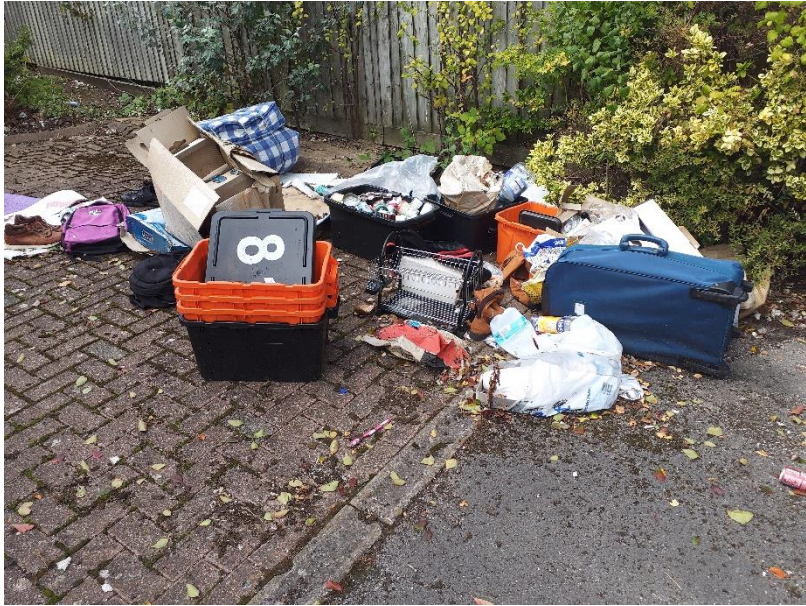
| 12 | <p>It is recommended that a suitable written record of periodic visual inspections of all other external communal areas is implemented by the RP, which should identify any potential hazards including slips or trips from major indentations or imperfections in any surface, including hard and soft landscaping. Any defects identified should be communicated to each resident and repaired by an approved contractor as a priority.</p> <p>Where refuse compounds are identified, an observation regarding waste management should be made as infrequent collections could result in broken glass in the vicinity of the compound leading to possible injury to playing children and a build-up of food waste, which would attract vermin such as foxes, rats or mice.</p> | 2 | B | <p>Ongoing action required</p> <p>DH inspect communal areas and arrange for removal if appropriate.</p> <p>Residents are reminded of sterile area policy on communal notice board</p> |
