# COMBINED FIRE AND HEALTH & SAFETY RISK ASSESSMENT.

| Address of premises: | 71 – 85 Farriers Close,<br>Swindon,<br>SN1 2QX |
| Date of fire risk assessment: | 19 <sup>th</sup> September 2024/ Reviewed September 2025 |

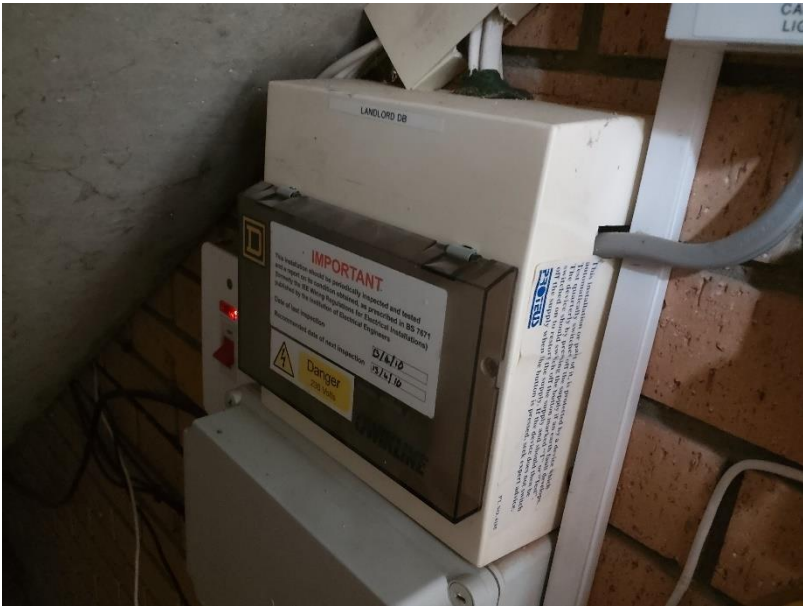
| Item | Recommendation | Priority | Timescale |
|---|---|---|---|
| 01 | <p>According to the sticker attached to the consumer unit, the fixed electrical installation was last inspected and tested in April 2010. All fixed electrical installations supplying the communal areas of a residential property should be inspected every five years in accordance with Electricity at Work Regulations / IEE Wiring Regulations Eighteenth Edition 2019 / British Standard 7671: 2018. It is therefore recommended that the client instruct a suitably qualified and competent electrical contractor to inspect and test the fixed electrical installation as a priority and a written Electrical Condition Report (EICR) obtained. It is recommended that the RP then create a management action to ensure the electrical installation is retested on a five yearly rolling basis.</p> | 1 | B |

| <p>According to the sticker attached to the consumer unit, the fixed electrical installation was last inspected and tested in April 2010.</p> <p>All fixed electrical installations supplying the communal areas of a residential property should be inspected every five years in accordance with Electricity at Work Regulations / IEE Wiring Regulations Eighteenth Edition 2019 / British Standard 7671: 2018.</p> <p>It is therefore recommended that the client instruct a suitably qualified and competent electrical contractor to inspect and test the fixed electrical installation as a priority and a written Electrical Condition Report (EICR) obtained. It is recommended that the RP then create a management action to ensure the electrical installation is retested on a five yearly rolling basis.</p> <p>There were no trailing leads or adapters identified within the common areas at the time of this assessment.</p> | | |

Ongoing action required  
DH maintain central record of EICR due dates and action accordingly

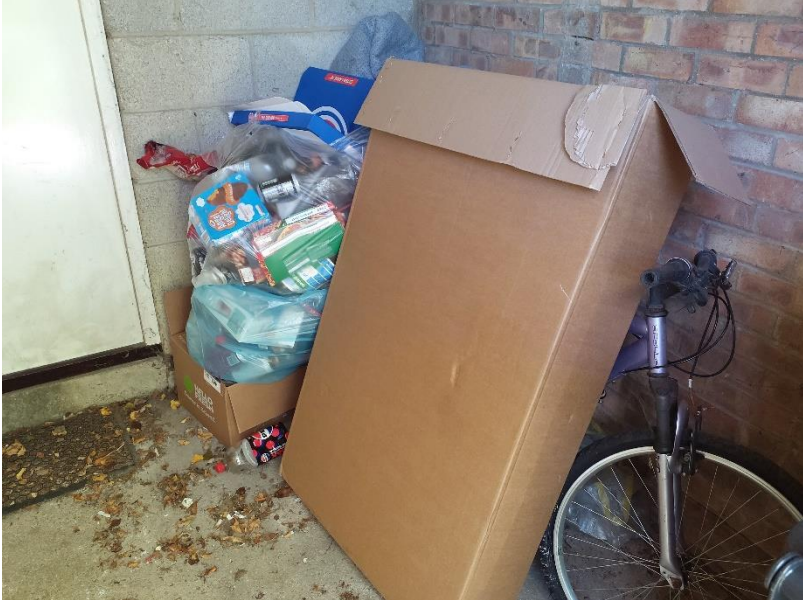
| 02 | <p>It was noted during this fire risk assessment that there was an excessive fire load of cardboard and rubbish located at the rear of the premises. It is recommended that this is removed as a matter of urgency in order to protect the premises from opportunist arson.</p> | 1 | A | <p>Ongoing action required<br/>Items Removed</p> <p>Residents are reminded of sterile action policy on communal notice board.</p> <p>CCTV being installed to prevent further issues.</p> |

| <p>Building security is good and the building is secured with an appropriate lock and an electronic entry system.</p> <p>It was noted during this fire risk assessment that there was an excessive fire load of cardboard and rubbish located at the rear of the premises. It is recommended that this is removed as a matter of urgency in order to protect the premises from opportunist arson.</p> | | |

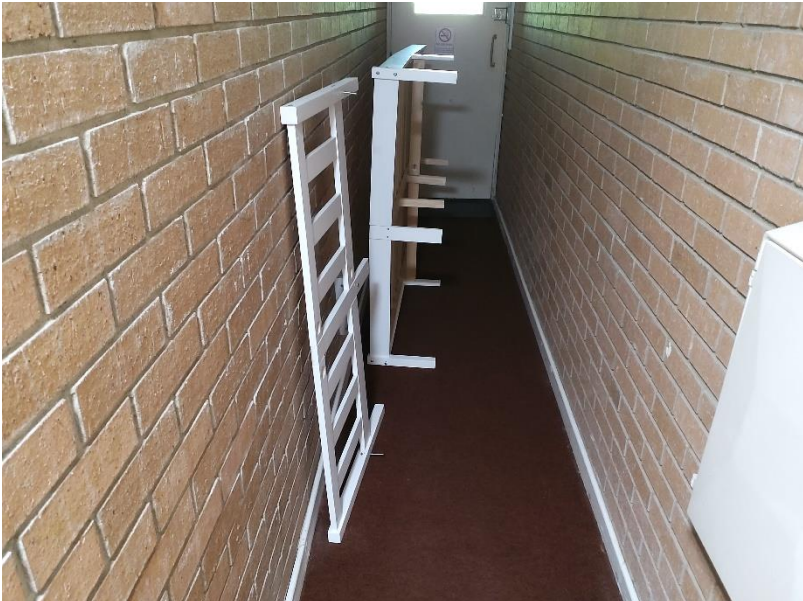
| 03 | <p>Housekeeping was found to be of a poor standard at the time of this assessment with the communal areas and escape routes congested with residents' possessions and storage. It is recommended that the client arrange for the communal areas to be cleared as a priority and all residents reminded of the importance of maintaining sterile communal areas and escape routes.</p> | 2 | B | <p>Ongoing action required<br/>Items removed</p> <p>Residents are reminded of sterile action policy on communal notice board</p> |

| <p>Housekeeping was found to be of a poor standard at the time of this assessment with the communal areas and escape routes congested with residents' possessions and storage. It is recommended that the client arrange for the communal areas to be cleared as a priority and all residents reminded of the importance of maintaining sterile communal areas and escape routes.</p> <p>Waste is managed by each resident with domestic style wheelie bins.</p> | | |

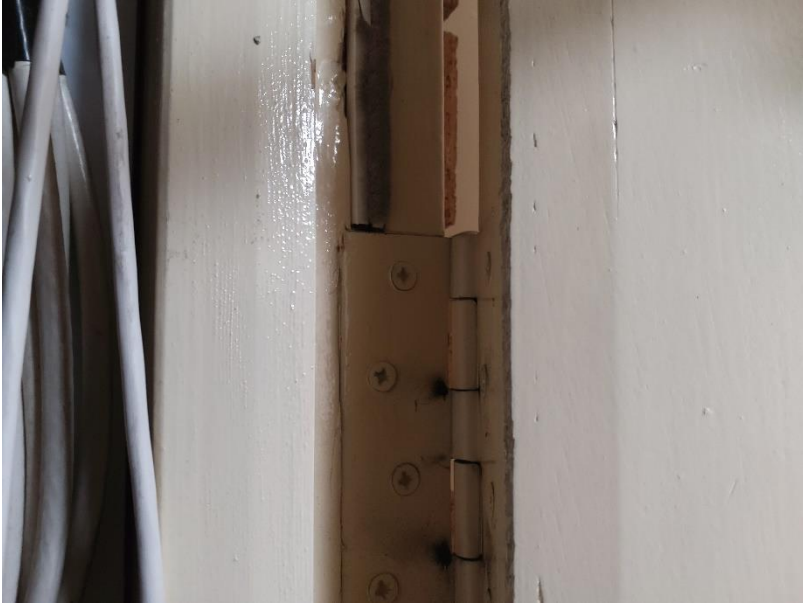
| 05 | <p>It was noted during this fire risk assessment that all lobby doors on the ground floor and the electrical intake cupboard doors within the premises were hung on three non-fire rated hinges which could affect the integrity of the door during high temperatures. It is therefore recommended that the RP instructs a suitably qualified and competent contractor to upgrade the hinges on all lobby doors to high temperature grade 13 hinges.</p> | 3 | B | Action complete |

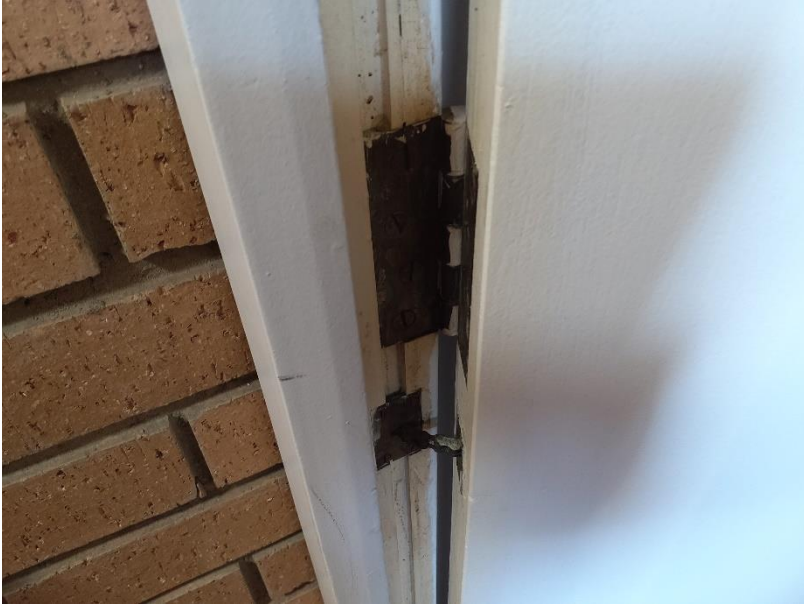
| 06 | <p>As per section 33.2 of Fire Safety in Purpose-Built Block of Flats a type 1 fire risk assessment requires us to conduct a fire door survey on a sample of flat front doors. The door to flat 81 was surveyed during this sample which appeared to be a notional fire door however it had no fire rated hinges or smoke seals.</p> <p>It is essential that each flat entrance door is a suitable fire door, providing a minimum of thirty minutes fire resistance, hung on three grade 13 hinges and having a functioning self-closing device fitted that positively closes the door on the latch, together with smoke and intumescent seals. It is recommended therefore that the RP instruct a suitably qualified and competent contractor to conduct a fire door inspection to all flat entrance doors and communal area doors providing advice on suitability. Any shortcomings identified by this inspection should be addressed as a priority by upgrading or replacing the door.</p> <p>Flat entrance doors, communal area doors, the seals and the self-closing devices should then be subjected to an annual inspection and maintenance schedule.</p> | 1 | B | <p>Action required</p> <p>DH inform owners accordingly.</p> <p>Last inspection carried out June 2025</p> |

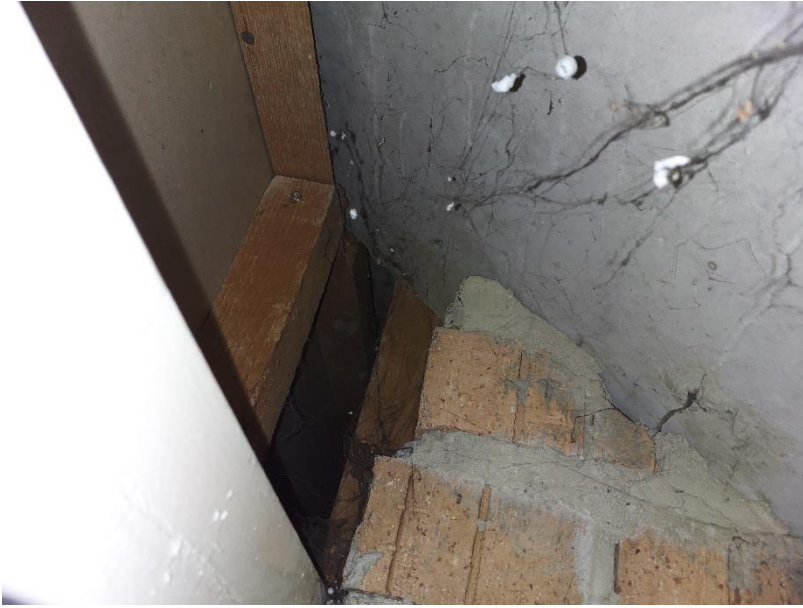
| <p>08</p> | <p>It was noted during this fire risk assessment that the compartmentation between the electrical intake cupboards and the communal areas were poor with fire stopping missing in areas or daylight shining through in breaches to the means of escape. The means of escape must be a protected route from any smoke or fire. It is therefore recommended that the RP instructs a suitably qualified and competent contractor to conduct a passive fire survey on all electrical intake cupboards, any deficiencies found should be actioned as a priority in order to protect the means of escape.</p> | <p>1</p> | <p>B</p> | <p>Action required<br/>Contractor to make repairs</p> |

| <p>It was noted during this fire risk assessment that the compartmentation between the electrical intake cupboards and the communal areas were poor with fire stopping missing in areas or daylight shining through in breaches to the means of escape. The means of escape must be a protected route from any smoke or fire. It is therefore recommended that the RP instructs a suitably qualified and competent contractor to conduct a passive fire survey on all electrical intake cupboards, any deficiencies found should be actioned as a priority in order to protect the means of escape.</p> | | |

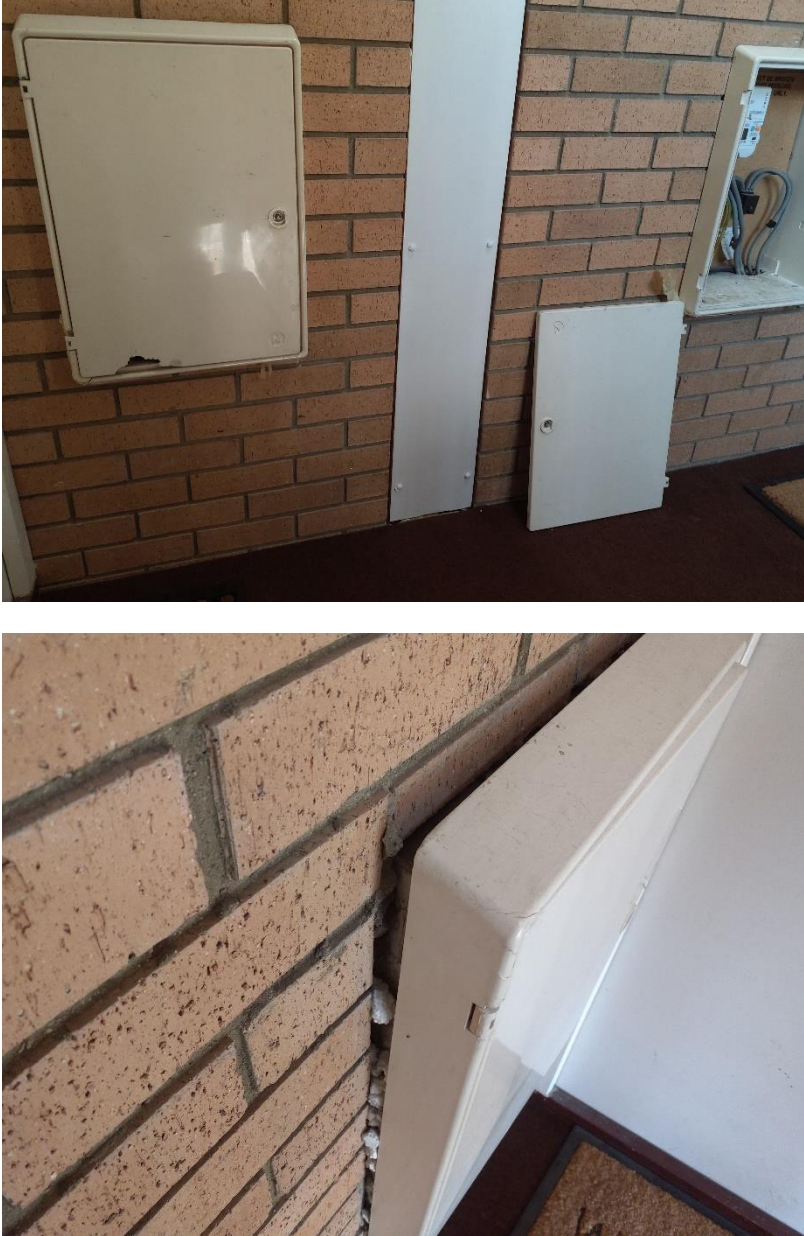
| 09 | <p>It was noted during this fire risk assessment that the electrical cabinets on the first and second floor were damaged which could allow smoke and fire to spread into the means of escape. It is therefore recommended that the RP instructs a suitably qualified and competent contractor to repair these cabinets in order to protect the means of escape.</p> | 2 | B | <p>Action required<br/>Boxes belong to individual apartment owners</p> <p>This assessment and other advice is provided to owners</p> |

| <p>It was noted during this fire risk assessment that the electrical cabinets on the first and second floor were damaged which could allow smoke and fire to spread into the means of escape. It is therefore recommended that the RP instructs a suitably qualified and competent contractor to repair these cabinets in order to protect the means of escape.</p> | | |
